*TMS320DM335*  
*Digital Media System-on-Chip (DMSoC)*  
**Silicon Revision 1.1**

## **Silicon Errata**

Literature Number: SPRZ287A  
July 2008—Revised October 2008

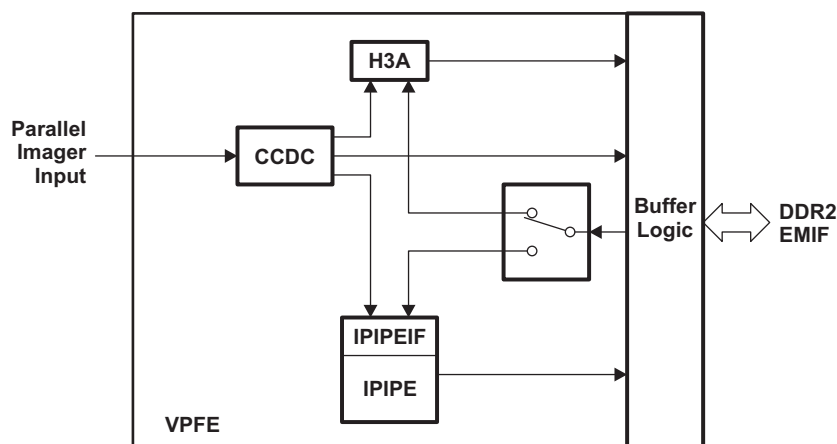
This problem affects H3A auto white balance, auto exposure, and auto focus when the image sensor data is large (i.e. greater than approximately 10 mega pixels) and the data path is from imager to CCDC to H3A .

When the H3A module receives more than 4096 pixel clock cycles between consecutive HD rising edges, the H3A internal line buffer may become corrupt. The internal line buffer address is reset to zero at HD rising edge, is incremented every pixel clock cycle, and wraps back to address zero after 4096 pixel clocks. H3A calculations may not be correct when the line buffer is corrupt.

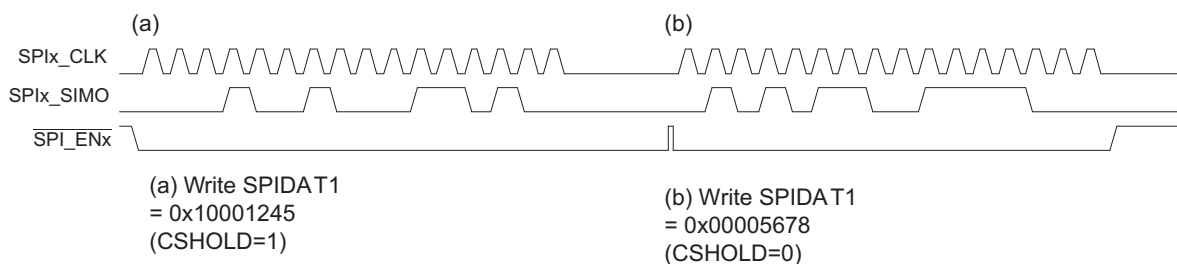
**Figure 3. Actual CSHOLD Behavior—32-Bit Writes to SPIDAT1**

Instead, what actually occurs is that  $\overline{\text{SPI\_ENx}}$  is momentarily de-asserted at the beginning of the second write, as illustrated in [Figure 3](#).

For each word in the sequence of words during which SPI\_ENx should be held low, write to the SPIDAT1 register with the CSHOLD bit set to '1'. Follow this by a write to only the CSHOLD field of SPIDAT1, setting CSHOLD = 0 to de-assert SPI\_ENx. See [Figure 5](#) for an illustration.

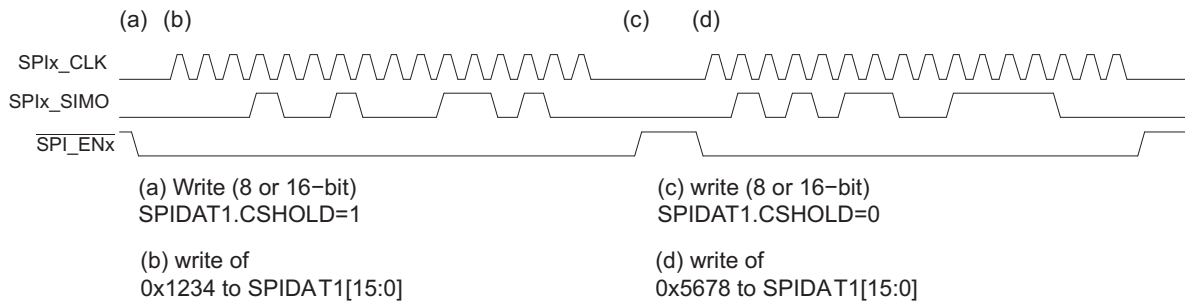
**Figure 4. Actual CSHOLD Behavior—Halfword Writes to SPIDAT1**

Both [Figure 2](#) and [Figure 3](#) assume that SPIDAT1 is written using a single 32-bit write instruction. If SPIDAT1 is instead written using an 8-bit or 16-bit instruction to write to the CSHOLD field, followed by a 16-bit write to the transmit shift register field of SPIDAT1, then what actually occurs is illustrated in [Figure 4](#). This is the same case illustrated in [Figure 3](#) except that the de-assertion of SPI\_ENx lasts for the duration between writing a '0' to the CSHOLD field and writing new data to the transmit shift register.

Alternatively, only write to the SPIDAT1 CSHOLD field before and after the transfer to toggle the SPI\_ENx pin. During the transfer, write only to the data field of SPIDAT1[15:0] using 16-bit (halfword) write commands. For an illustration, see [Figure 6](#).
