*TMS320DM335*  
*Digital Media System-on-Chip (DMSoC)*  
**Silicon Revision 1.1**

## **Silicon Errata**

Literature Number: SPRZ287A  
July 2008—Revised October 2008

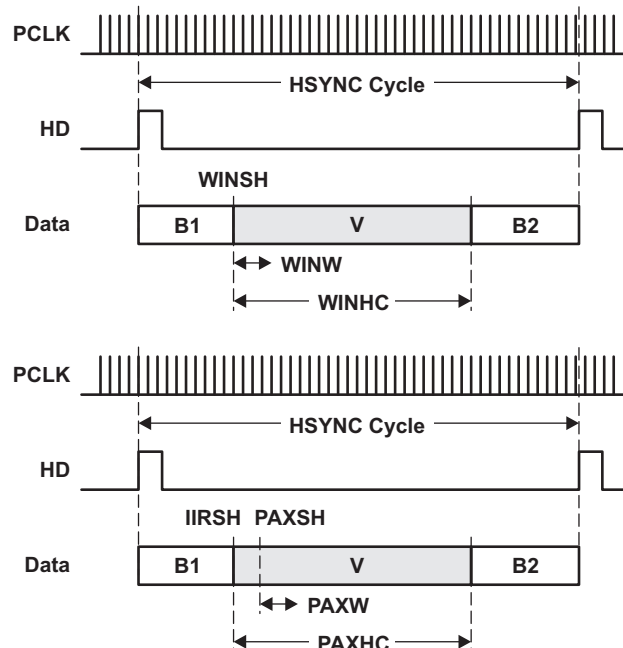
- $B1$  = Data area from HD rising edge to start of valid AEW/AF data.
- $V$  = Valid AEW/AF data area. This is the data area for AEW/AF calculations. This area is specified using registers in the H3A module. Note that the registers are different for AEW and for AF. For AEW, bits WINSH specify the horizontal start position of the AEW windows, bits WINW specify the horizontal width of the windows, and bits WINHC specify the total number of windows. The total number of pixels in the valid AEW data area is equal to  $V = \text{WINW} * \text{WINHC}$ . For AF, bits IIRSH specify the horizontal start position of the IIR filter, bits PAXSH specify the horizontal start position of the AF paxels, bits PAXW specify the horizontal width of the paxels, and bits PAXHC specify the total number of paxels. The total number of pixels in the valid AF data area is equal to  $V = [(\text{PAXSH} - \text{IIRSH}) + \text{PAXW} * \text{PAXHC}]$ . See the VPFE PRG for complete bit descriptions.

- $B2$  = Data area from end of valid AEW/AF data to next HD rising edge.

2. Use the imager's movie readout mode.

In the imager's movie readout mode the problem does not occur, because the number of horizontal pixels and blanking are less than 4096 pixels and the H3A module receives less than 4096 pixel clock cycles between consecutive HD rising edges.

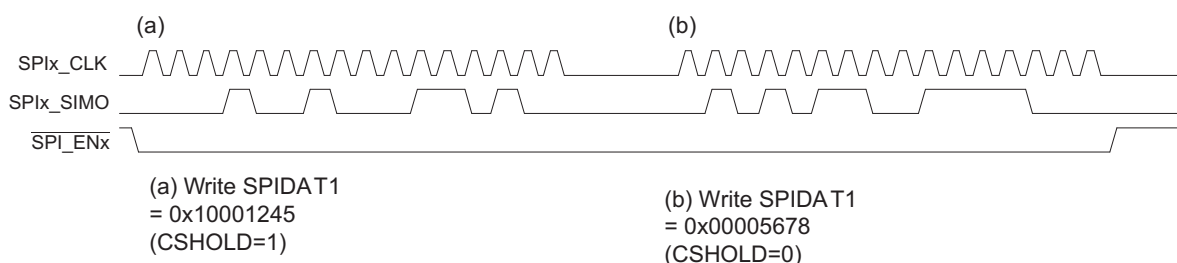
**Figure 2. Expected CSHOLD Behavior**

According to the SPI specification, the following sequence should produce the expected result as illustrated in [Figure 2](#):

- Write 0x10001234 to SPIDAT1 for transmission of 0x1234 (CSHOLD = 1)
- Write 0x00005678 to SPIDAT1 for transmission of 0x5678 (CSHOLD = 0)

Instead, what actually occurs is that  $\overline{\text{SPI\_ENx}}$  is momentarily de-asserted at the beginning of the second write, as illustrated in [Figure 3](#).
