## *Errata and Added Information to* **MC68360 Quad Integrated Communication Controller User's Manual Rev 1**

January 8, 1998

This document describes the latest information and changes to the first revision of the MC68360 user's manual.

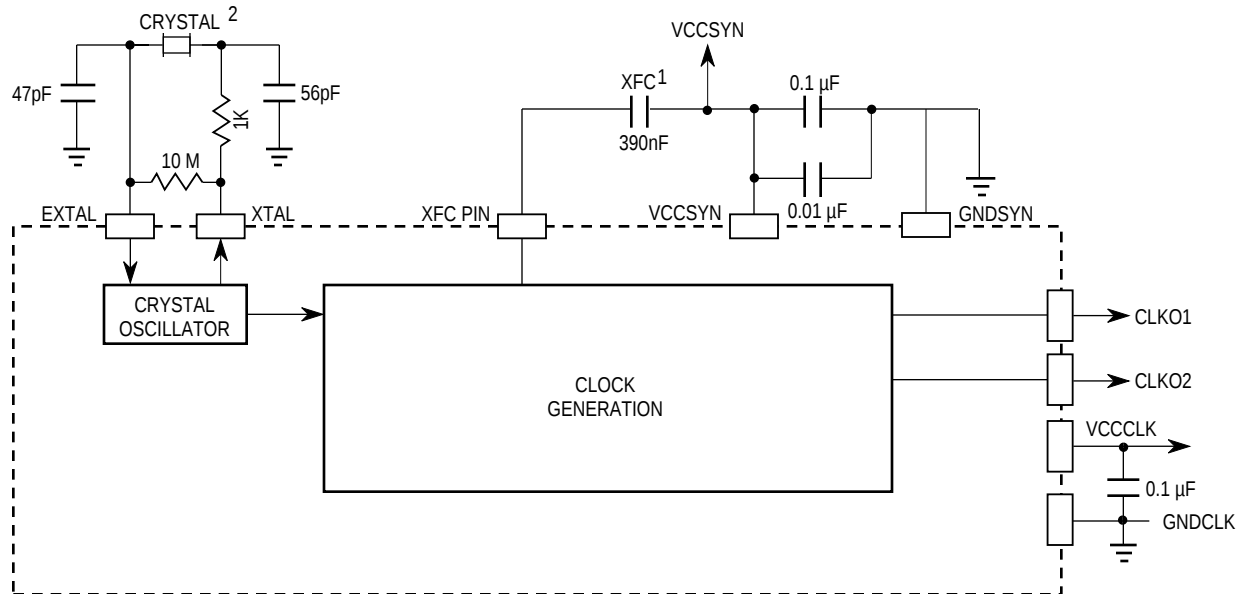
Also on page 6-14 the following figure should be added.

NOTE:

1. Must be low-leakage capacitor. See Section 10 Electrical Characteristics for recommended values.
2. Values are for 4.194MHz crystal and may vary due to capacitance on PCB.

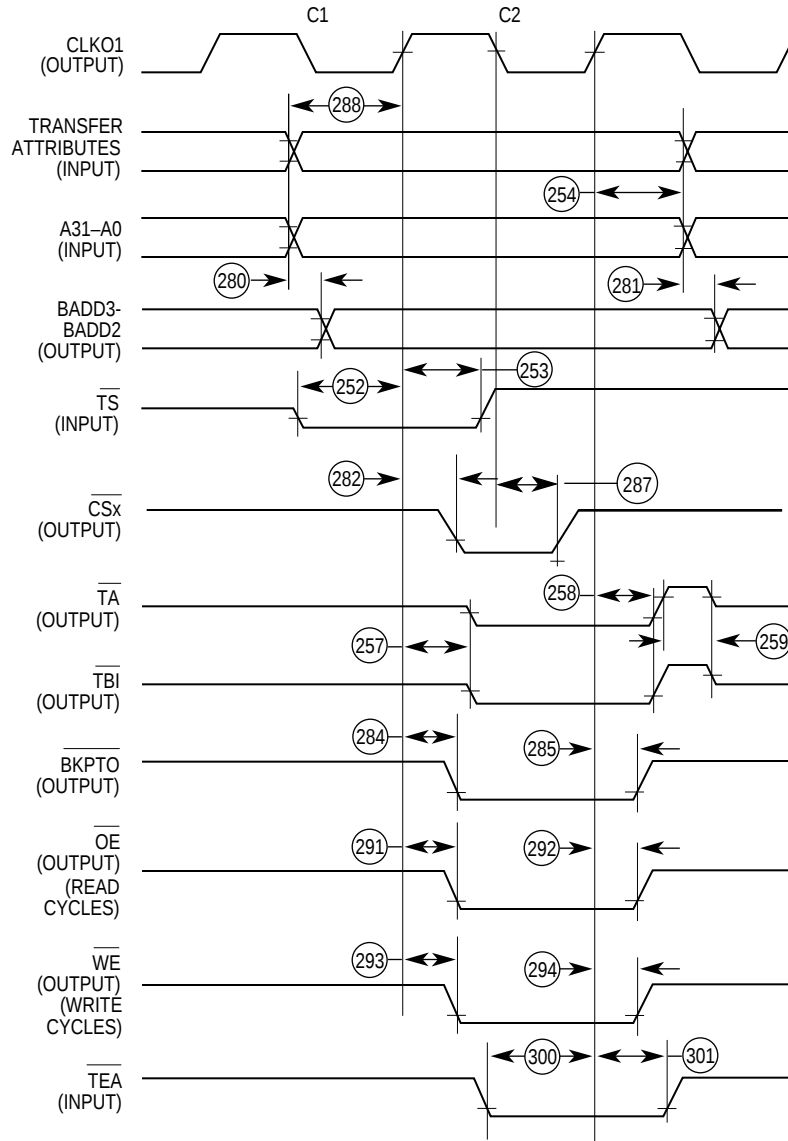
**Figure 10-44(b) MC68040/EC040 SRAM Write cycle (TSS40=0, CSNT40=1)**

The following figure should be added after figure 10-44(a)

NOTE: MC68040 Transfer Attribute Signals = SIZx, TTx, TMx, R/W, LOCK

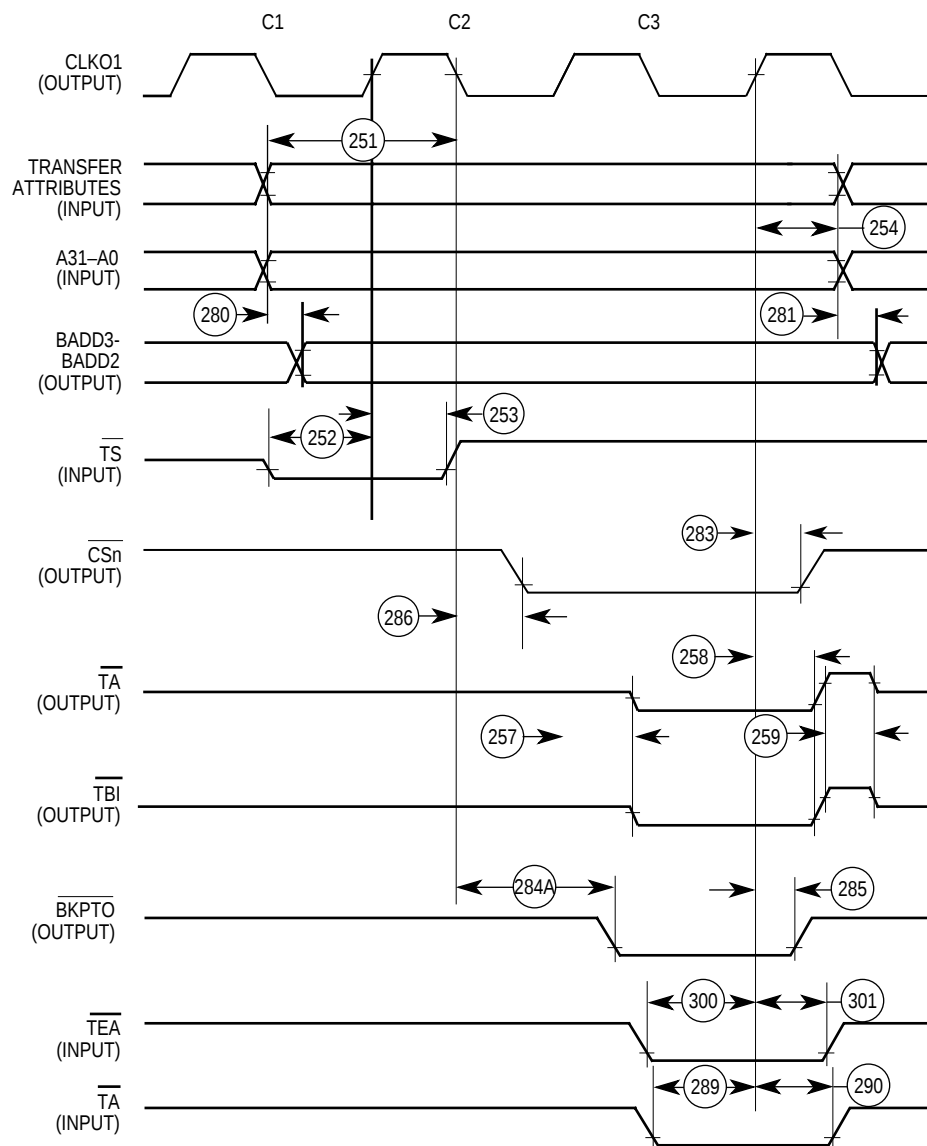
**Figure 10-45(b) MC68040/EC040 SRAM Read Cycle (TSS40=1, CSNT40=1)**

$\overline{OE}$  and  $\overline{WE}$  signals are not supported when TSS40 is set to 1.

The following figure should be added below figure 10-45(a)

NOTE: MC68040 Transfer Attribute Signals = SIZx, TTx, TMx, R/W, LOCK  
OE and WE are not supported when TSS40 is set to 1
